901 HERMOSA AVENUE HISTORIC RESOURCES ASSESSMENT

HERMOSA BEACH, CALIFORNIA
[24017]

PREPARED FOR
901 HERMOSA PARTNERS LLC

April 17, 2024

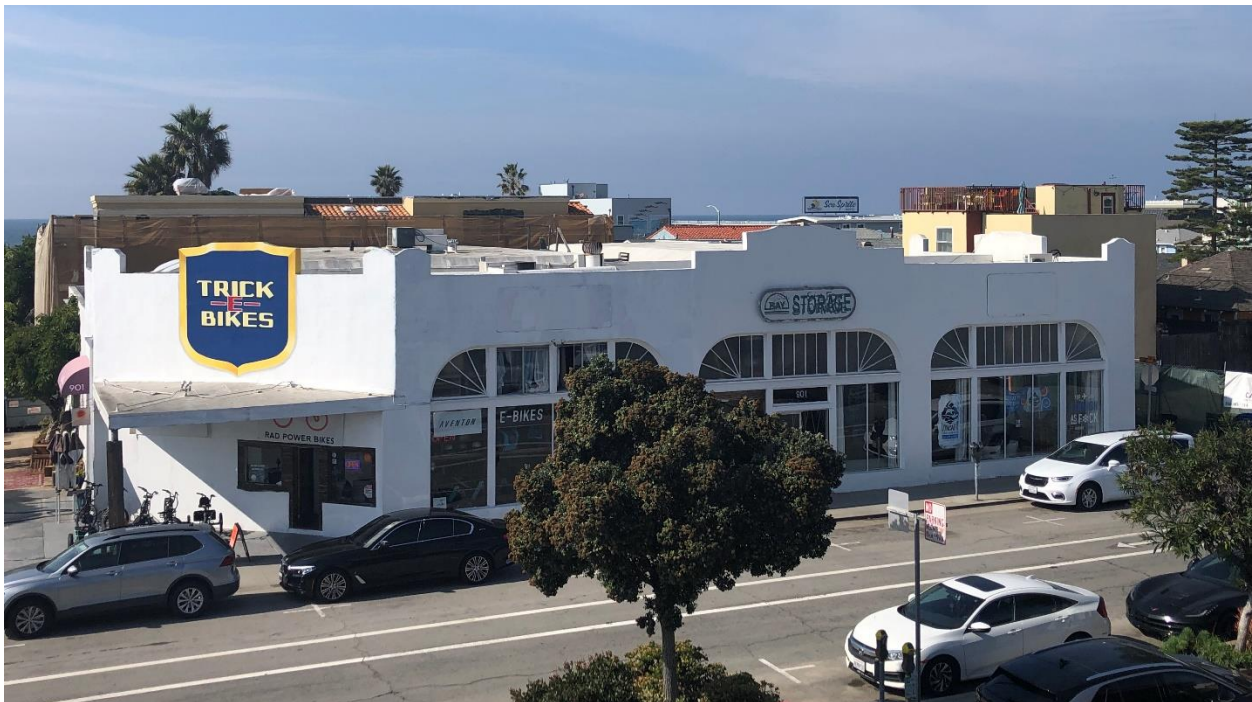
901 Hermosa Avenue is occupied by a high-bay, one-story wood-frame building with box-like massing and a rectangular footprint except at its southeast corner where the façade is angled at forty-five-degrees (**Figure 4**). The design of the building is typical of one-part vernacular commercial construction that provides a sizable wall area between windows and cornice for signage, a feature that also makes the façade appear larger.¹⁰ The subject property's stucco finish and arched window openings modestly reference the Mission Revival style popular in 1920s Southern California.

Figure 4: Primary (east) façade of 901 Hermosa Avenue, view northwest.

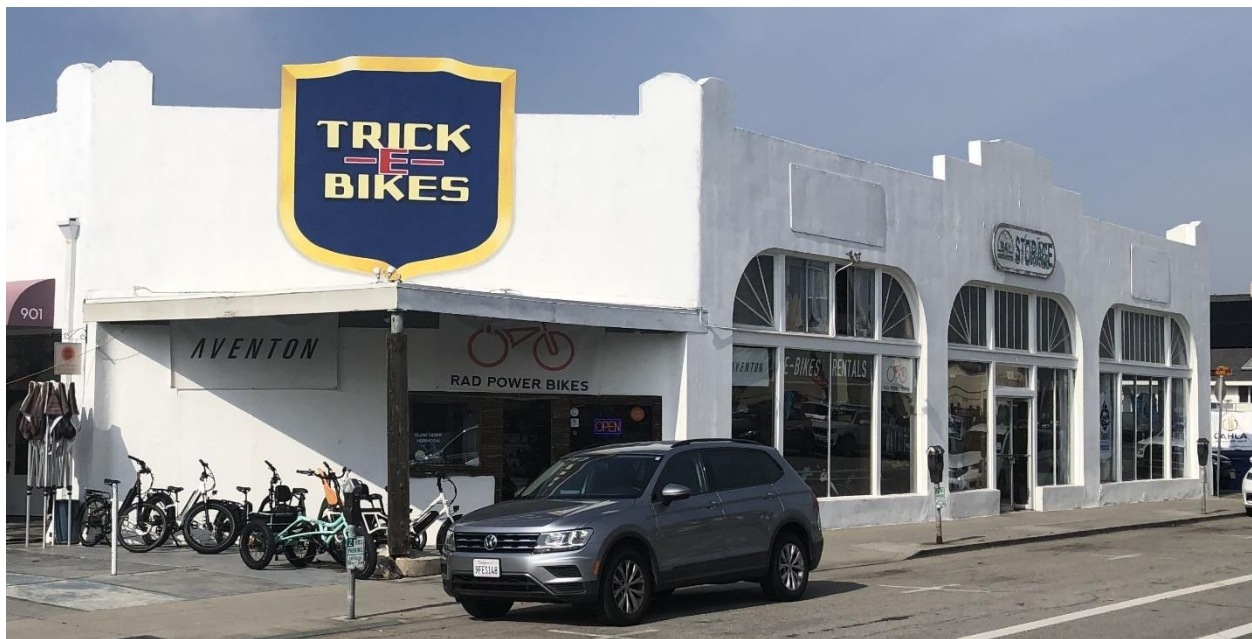
The primary (east) facade consists of two parts: the main storefront parallel to Hermosa Avenue and an angled southeast façade at the corner. The southeast and east-facing façades have stepped parapets (**Figure 5**).

Figure 5: Primary façade (right) and southeast angled corner façade (left), view northwest.

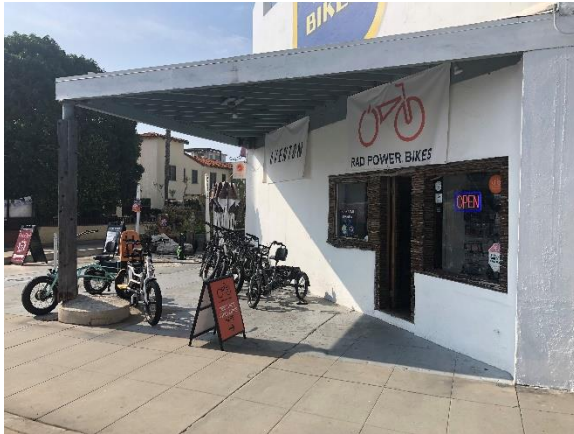
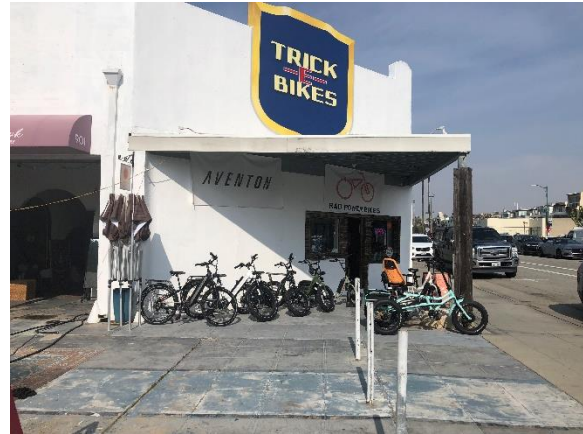
The angled southeast corner wall features a triangular wood-framed canopy over a single-panel entry door flanked by square, fixed wood-frame windows (**Figure 6 and Figure 7**). The long edge of the canopy is attached to the angled wall and its southeast corner is supported by a wood-encased round metal column seated on a round concrete base. The fenestration is situated on the north

(right) half of the wall, where its perimeter is surrounded with horizontally-layered tree branch segments that form a rustic frame.

Figure 6: Southwest corner, view west.

Figure 7: Southwest corner, view north.

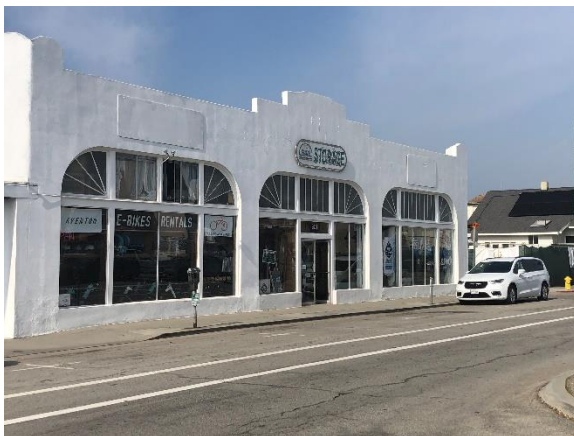
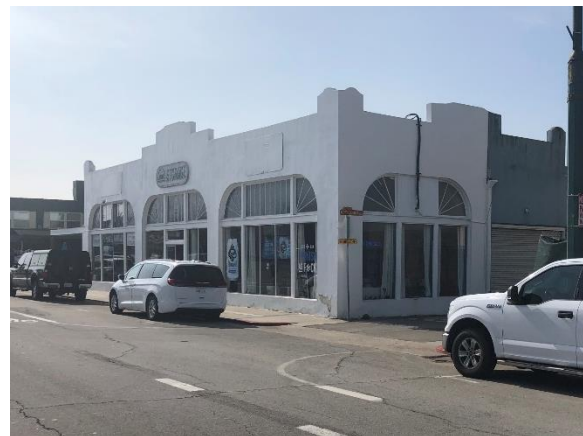
Figure 8: East façade, view northwest

Figure 9: East façade, view southwest

The storefront portion of the primary façade has three window bays, each with an arched opening and multi-light display window (**Figure 8 and Figure 9**). The middle section of the south (left) transom has been subdivided to accommodate a new center mullion flanked by metal-frame single-light sliding windows. The center window retains its original configuration except for new paired metal-frame entry doors. The north (right) window retains its original configuration. A small number of transom lites have been replaced with new glass. Sign boards are attached to the wall above the center of each window opening.

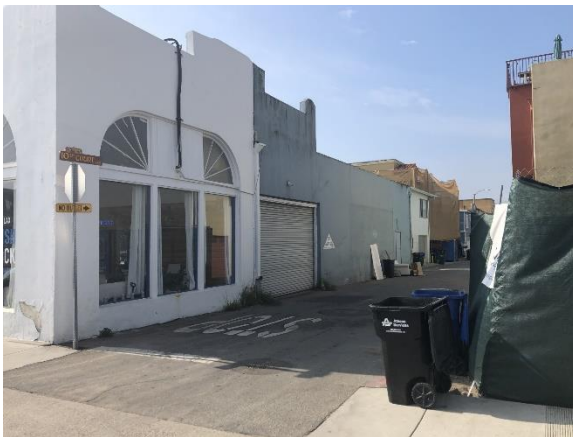
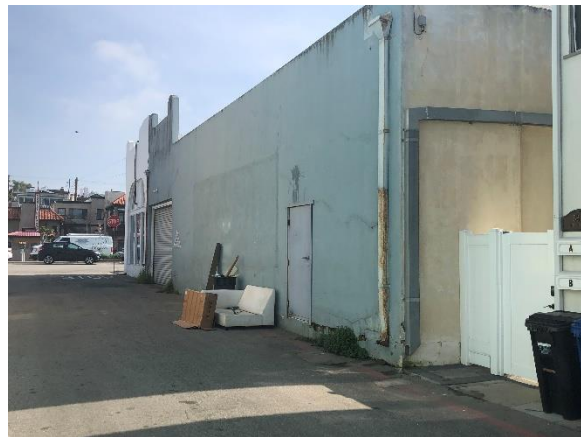
The north façade is organized in three sections, the east and center of which are located beneath the stepped parapet (**Figure 10 and Figure 11**). The east (left) section features a typical arched display window; the center section of its transom has been covered with an opaque panel. The middle section of the façade is penetrated by a rectangular garage door opening with concrete wheel guards at its base. The long, west (right) section has an infilled rectangular opening at its center; its proportions suggest that it was formerly a second garage door. A single metal panel door is located at the far west end.

Figure 10: North façade, view southwest.

Figure 11: North façade, view southeast.

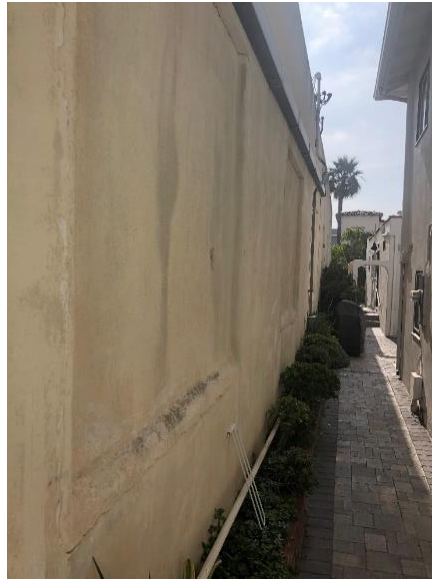
The west façade currently has no openings. Five recessed stucco panels, evenly arranged across the center of the wall plane, are infilled former window openings (**Figure 12**).

Figure 12: Rear (west) elevation, view south.

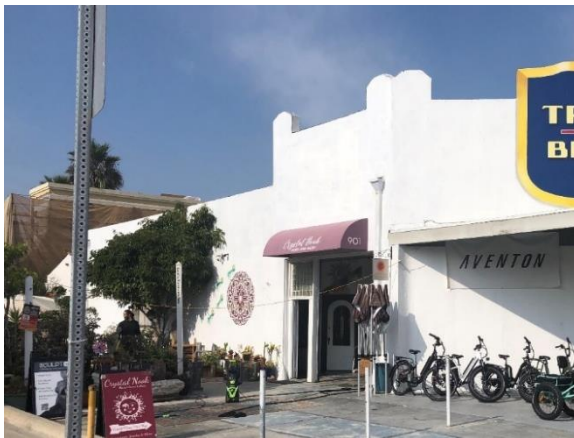
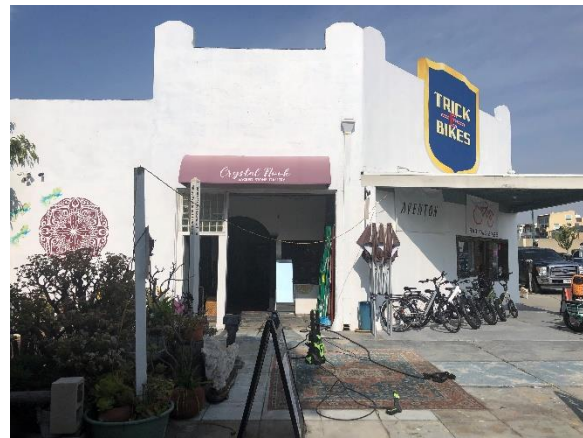
The south façade is organized in two sections, which are located to the west of the angled southwest corner wall (**Figure 13 and Figure 14**). The west (left) section of the façade has a large rectangular plaster patch covering an infilled window opening. The center of the wall currently features a metal-framed three-part fixed and sliding window with an interior security grille. The window is framed with a simple painted wood surround (**Figure 13**). The east section has stepped parapet and is penetrated by a wide garage door opening with concrete wheel guards at its base and a cloth awning above. The opening has been subdivided to accommodate a single panel entry door with a glass-block transom on its west side and a smaller rolling security door on its east side (**Figure 14**).

Figure 13: South façade, view northwest.

Figure 14: South façade, east end, view north.

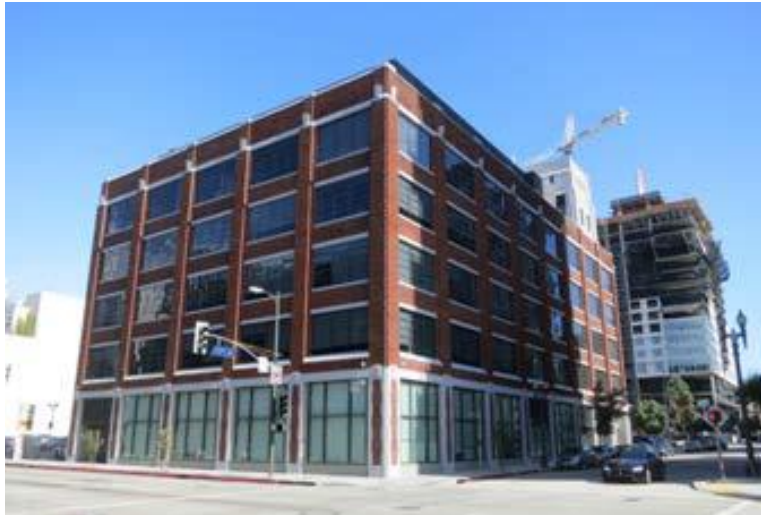
Figure 24: 1050 Hope Street (Los Angeles) was built as a showroom and service center for the Willys-Overland Company in 1916 and served as such through 1932, photo circa 2015. Source: *Survey-LA*.

In the early 1920s, urban dealerships began to combine auto servicing and repair with sales (**Figure 24**). This required the construction of larger, often multi-story, facilities with ramps and the volume to accommodate multiple vehicles. Façades continued to feature historicist detailing with the only feature identifying the buildings as auto service facilities being factory sash windows and vehicle-sized openings.²²

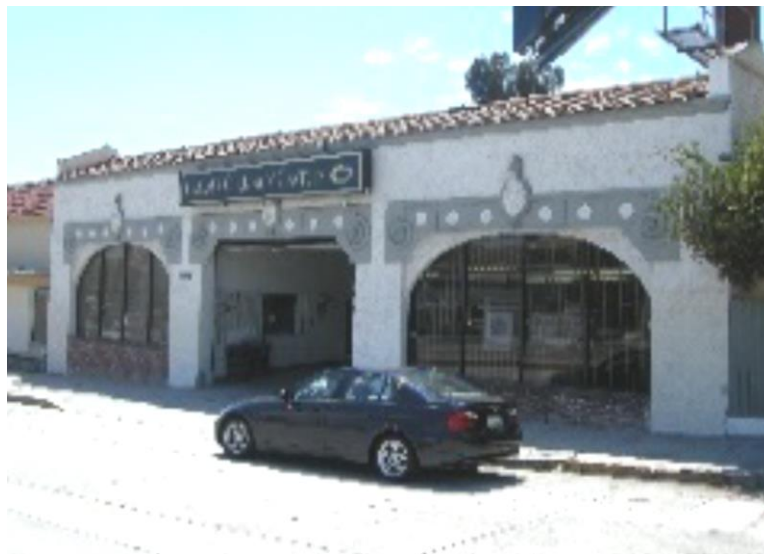
Figure 25: Former showroom and repair facility (Hollywood) built in 1925, photo circa 2015. Source: *Survey-LA*.

Outlying business districts continued to build small single-story outlets on local main streets (**Figure 25**). The suburban showrooms adopted a common three-bay façade composition consisting of an elaborate center entrance with symmetrically flanking show windows placed directly on the street without setback. These were essentially single-story versions of the more elaborate central business district dealerships, and they maintained a footprint similar to that of an early livery stable. The suburban buildings typically adopted the period revival styles popular at the time.²³

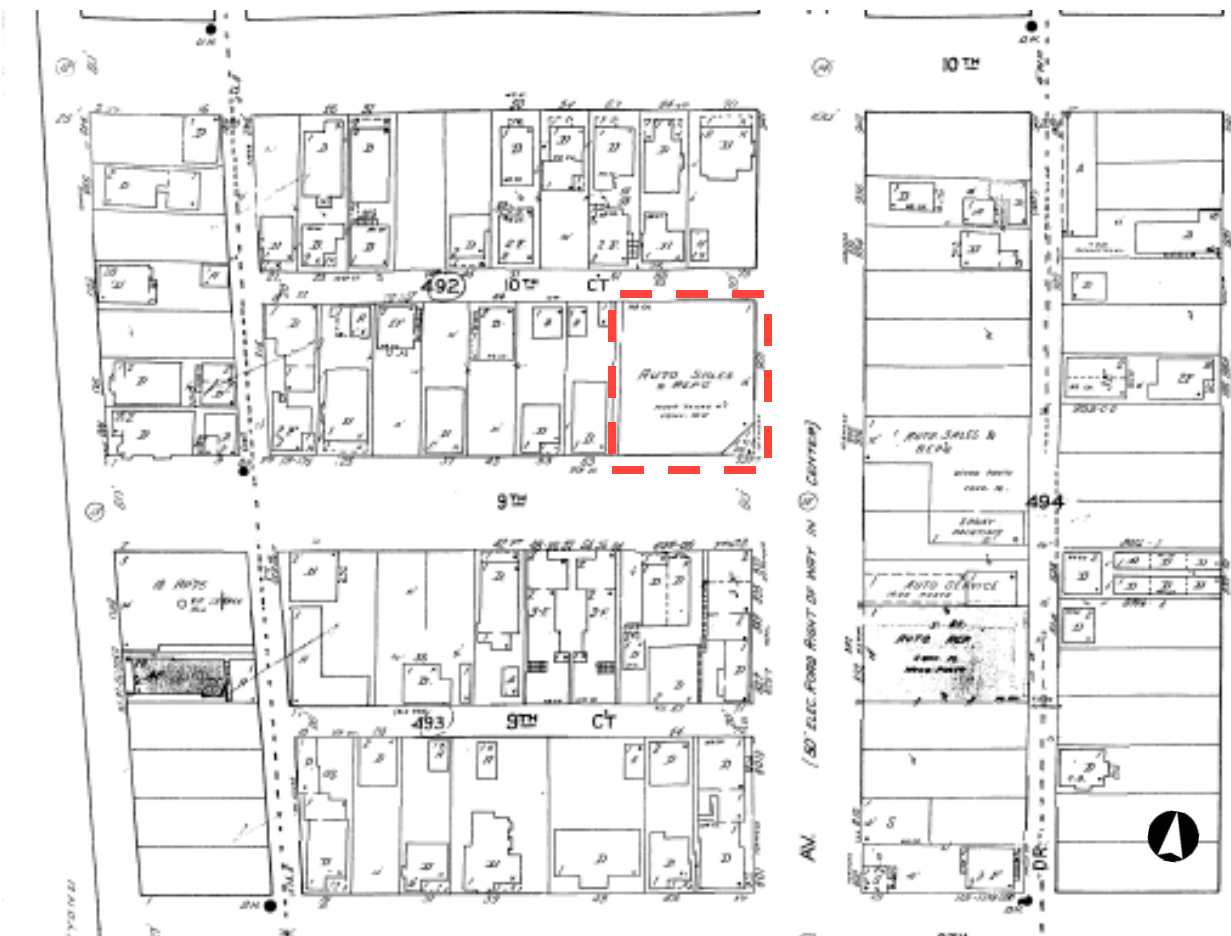
A 1927 Sanborn Map Company fire insurance map showed the footprint of the auto sales and repair building, including the angled façade and canopy. The map indicated that the building had a wood truss roof and concrete floor, and also showed the residential buildings to the west and commercial buildings along Hermosa Avenue (**Figure 29**).

Figure 29: Sanborn Map Company fire insurance map of Hermosa Beach, Sheet 15, January 1927 – September 1946. The location of the subject property is outlined in red. Source: Los Angeles Public Library. Edited by Page & Turnbull.

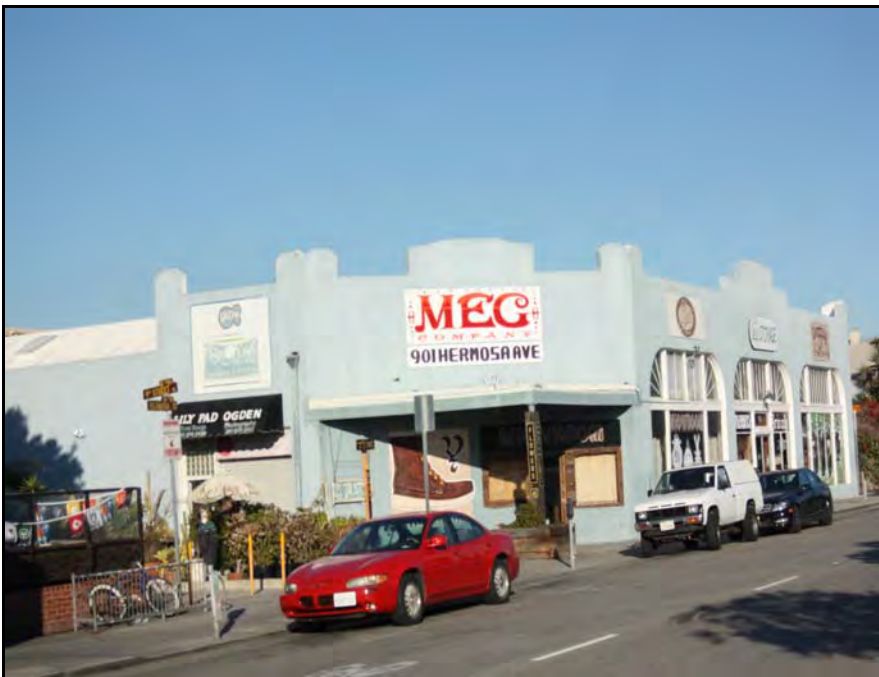
P5b Description of Photo:
(View, date, accession #)
North West, 12/12/13
